METHODOLOGY FOR THE REPAIR OF DENSO COMMON RAIL SOLENOID INJECTORS

This paper presents the problems of Denso Common Rail solenoid injector verification and repair. Due to conscious policy of the manufacturer who does not offer spare parts or special tooling, their servicing comes down most frequently to external cleaning, internal rinsing by the thermo-chemical method, and testing on test benches. Based on the analysis of failures and malfunctions being most frequently observed, own methodology for the repair process have been presented, specifying the successive stages of disassembly and final assembly. A possibility of effective fuel metering correction has been demonstrated, which is presented on the example of injectors in a 2.2 HDI engine of Citroën Jumper II delivery van.

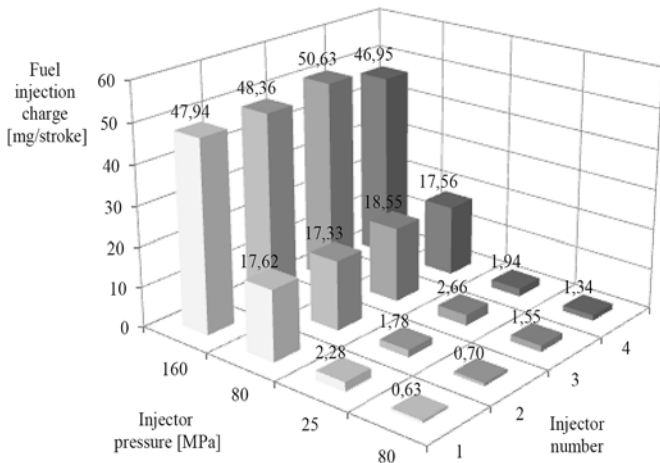
The analysis of fuel delivery rate in the „iVM” test showed that idle run fuel charges for injector 2 and 4 were too small, amounting to 1.78 mg/stroke and 1.94 mg/stroke, respectively. The results pointed to the worsening of the needle and nozzle assembly co-operation, which became apparent only when setting low pressure on a tester. Malfunction of this type is one of the most frequently detectable defects, being also encountered in the products of other manufacturers, but it is usually observed in the injectors of engines with a relatively low operational mileage. In such cases, a change in the initial stress of lower spring is required, which reduces the lift of needle at low pressure and in consequence the charge of injected fuel. The correction of fuel charge is conducted by reducing needle washer thickness.

Fig. 4. Results for injected fuel delivery rate according to injection pressure obtained from the initial test for the injectors being analysed

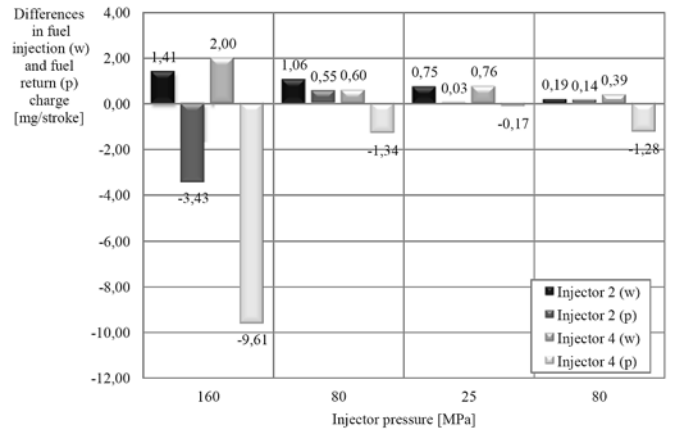
Fig. 7. Differences in fuel injection and fuel return charge according to injection pressure in the injectors being repaired

An intermediate effect on other fuel delivery rates was observed, in particular reduction of the fuel amount on most overflows. In injector 2, this effect occurred only with the full load, while for other fuel charges (emission, idle run and pilot fuel charges) the increase was negligibly small. In this respect, the repair process should be also positively assessed because excessive amount of fuel on the return might manifest in difficulties in starting the engine, its spontaneous stoppage, and observable loss of power at different load ranges. In the products being analysed, these problems should not be found. The test results being obtained on test benches and the verification of parts, in which other causes were excluded, e.g. damages to valve unit, loss of internal leak-tightness, nozzle hole plugging, is evidence of this.
