METHODOLOGY FOR THE REPAIR OF DENSO COMMON RAIL SOLENOID INJECTORS

This paper presents the problems of Denso Common Rail solenoid injector verification and repair. Due to conscious policy of the manufacturer who does not offer spare parts or special tooling, their servicing comes down most frequently to external cleaning, internal rinsing by the thermo-chemical method, and testing on test benches. Based on the analysis of failures and malfunctions being most frequently observed, own methodology for the repair process have been presented, specifying the successive stages of disassembly and final assembly. A possibility of effective fuel metering correction has been demonstrated, which is presented on the example of injectors in a 2.2 HDI engine of Citroën Jumper II delivery van.

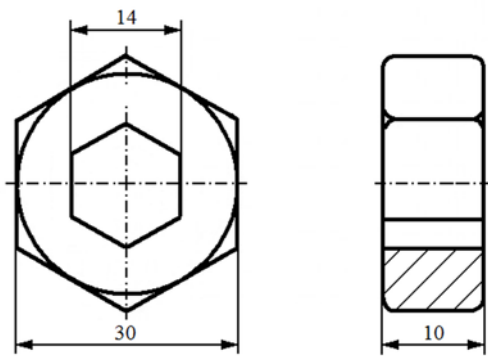
Fig. 3. An adapter enabling nozzle nut to be unscrewed

To unscrew nozzle nuts, a special adapter was made, using a 30 mm hexagonal iron (Fig. 3). This was a necessary condition to carry out disassembly because adapters for injectors of other manufacturers have different dimensions.

When unscrewing the nut, a torque of 150 Nm should not be exceeded because the sealing surface may be permanently damaged and the pins locating nozzle position against a fuel feed hole may be shorn. After this step, an access to the following elements was gained: needle, lower spring, needle washer, spindle and guide plunger. It should be noted that any resistance occurring when removing the latter from the main body is evidence of permanent seizure and impossibility to repair the injector.
