KOMOREK A, PRZYBYŁEK P. Examination of the influence of cross-impact load on bend strength properties of composite materials, used in aviation. *Eksploatacja i Niezawodność – Maintenance and Reliability* 2012; 14 (4): 265–269.

Andrzej KOMOREK
Paweł PRZYBYŁEK

EXAMINATION OF THE INFLUENCE OF CROSS-IMPACT LOAD ON BEND STRENGTH PROPERTIES OF COMPOSITE MATERIALS, USED IN AVIATION

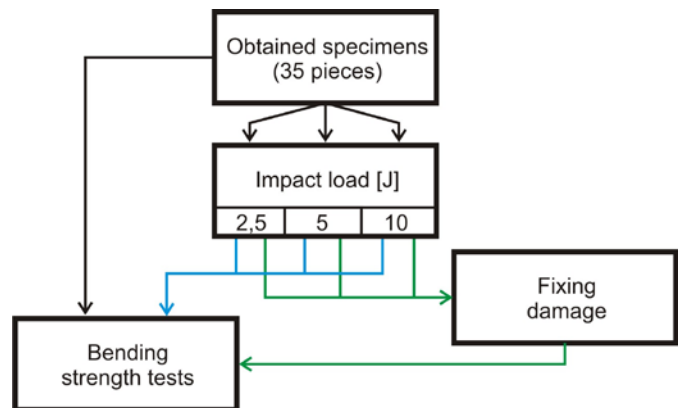
Fig. 3. Research diagram

The aim of the carried out research was to determine the influence of low-energy impact load upon the mechanical properties of the composite material, i.e. laminate, used for the covering of the front part of the aircraft fuselage. The research was conducted on the basis of a programme specified by an algorithm (Fig. 3). It bases upon the assumption that delamination and cracking remain the main causes of laminate strength reduction, after impact loading [5, 9, 12, 15].

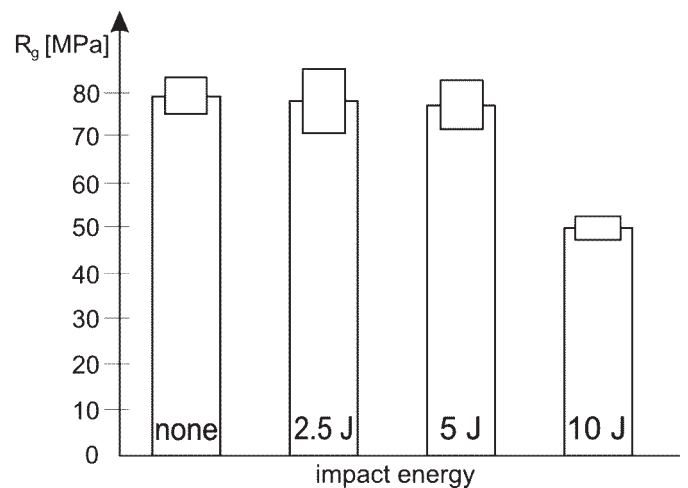
Fig. 11. Bending strength of the test specimens

The impact load of 2.5 J and 5 J causes a slight decrease of the bending strength. The specimens which underwent a 10 J impact load
