KOMOREK A, PRZYBYŁEK P. Examination of the influence of cross-impact load on bend strength properties of composite materials, used in aviation. *Eksploatacja i Niezawodność – Maintenance and Reliability* 2012; 14 (4): 265–269.

Andrzej KOMOREK
Paweł PRZYBYŁEK

EXAMINATION OF THE INFLUENCE OF CROSS-IMPACT LOAD ON BEND STRENGTH PROPERTIES OF COMPOSITE MATERIALS, USED IN AVIATION

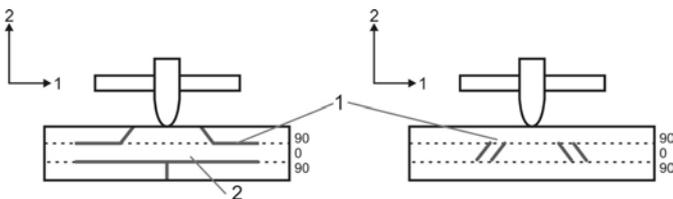
Fig. 1. Initial damage in 0/90/0 composite due to cross-impact loads: 1 – base damage, 2 – delamination [11]

- base damage – cracking of the base along fibres, caused by their extending, gripping or cutting (Fig. 1);
- delamination (separation of layers) – caused by stresses among various layers of the laminate (Fig. 1);
- fibre damage – it commonly appears on the surface directly under the impact of a shock load, as a result of cutting forces which arise while bending the acting element; also on the side of the laminate away from the bending tensions;
- perforation – it is macroscopic damage which emerges after destroying the base and the fibres, finally leading to the puncture (destruction) of the material's structure.

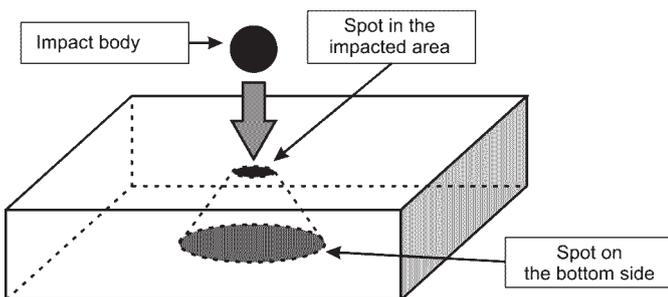
Fig. 2. Shape of an impacted area in a composite sheet after low-energy impact loading

In case of minor impact loading (several joules) around the impact area, there is a slight spot, difficult to identify. The examination of the microstructure shows that beneath the spot there may emerge an area similar to a cut cone (Fig. 2). The tip of the cone overlaps the impacted spot (external surface of the element), whereas the base of the cone

lies on the opposite (i.e. inside) surface of the element wall.

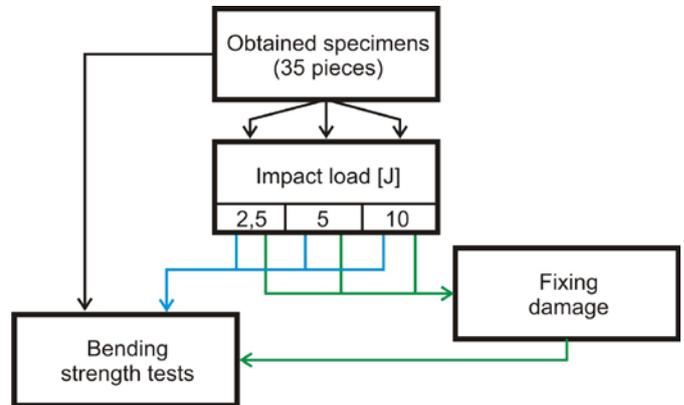
Fig. 3. Research diagram

The aim of the carried out research was to determine the influence of low-energy impact load upon the mechanical properties of the composite material, i.e. laminate, used for the covering of the front part of the aircraft fuselage. The research was conducted on the basis of a programme specified by an algorithm (Fig. 3). It bases upon the assumption that delamination and cracking remain the main causes of laminate strength reduction, after impact loading [5, 9, 12, 15].

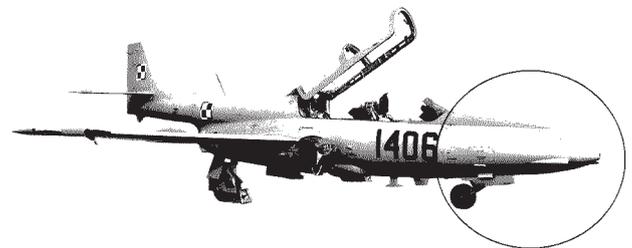
Fig. 4. The TS-11 “Iskra” aircraft; marked test element (picture by P. Idzkiwicz)

The specimens, rectangular in shape, were obtained from an aircraft covering element – the TS-11 “Iskra”, approximately 30 years in service. We paid particular attention to the lack of wear and tear as well damage emerging at a later time, during storage. The specimens were derived from places whose element curving was minimal due to the fact that the shapes had to be close to rectangular. The test material was made with layered composite on the epoxy-resin base, reinforced with three layers of glass fabric, of 300 g/m² basis weight.

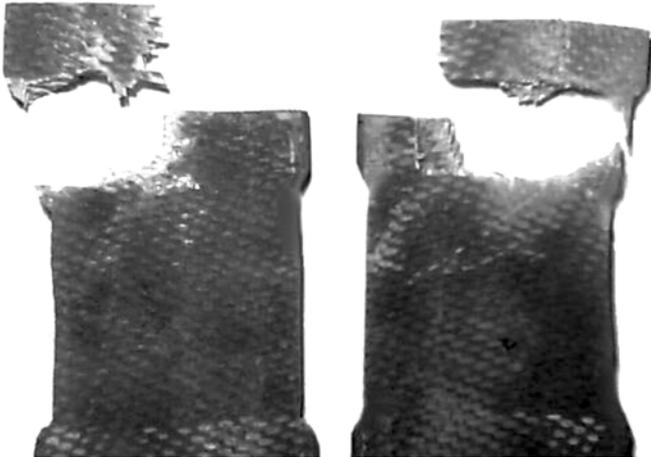
Fig. 5. Specimens for preliminary tests, broken in the fixing point

In case of the expansion test, it was problematic to select proper specimen measurements for the research. EN ISO 527-2:1998 norm specifies the specimen width as smaller than the aperture diameter in the plates which fix the specimen on the impact loading test machine (40 mm). The specified measurements make it impossible to copy the conditions which give rise to cross-impact bend in the aircraft covering. Finally we decided to carry out a series of tests which adopted different sizes of specimens. The conducted experiments proved that the adoption of such specimens does not solve the problem as even tiny differences in specimens' thickness, (which usually occur), cause

breaking of specimens in the place where they were fixed during the check, in spite of making them a bit more narrow (Fig. 5).

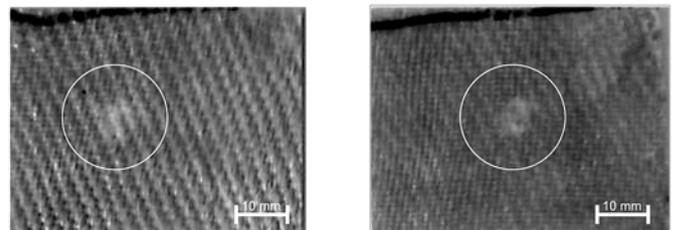
Fig. 7. Specimens after an impact load of 2.5 J (inside)

In case of cross-impact load of 2.5 J, the external surface of the element (specimen) does not show visible traces of the impact load; on the other hand, on the inside of the element one could notice a small delamination bulge (Fig. 7). The outer structure of the specimen did not become damaged.

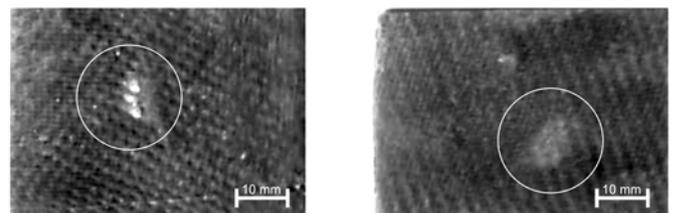
Fig. 8. Specimen after impact load of 5 J (inside)

not show visible damage; however observation of the inside pointed to the emergence of a clear delamination area, with noticeable base cracking (around 8 mm in length), which had a radial shape, starting at a point of the impact load (Fig. 8). On the small area there were also damaged fibres of the reinforcement.

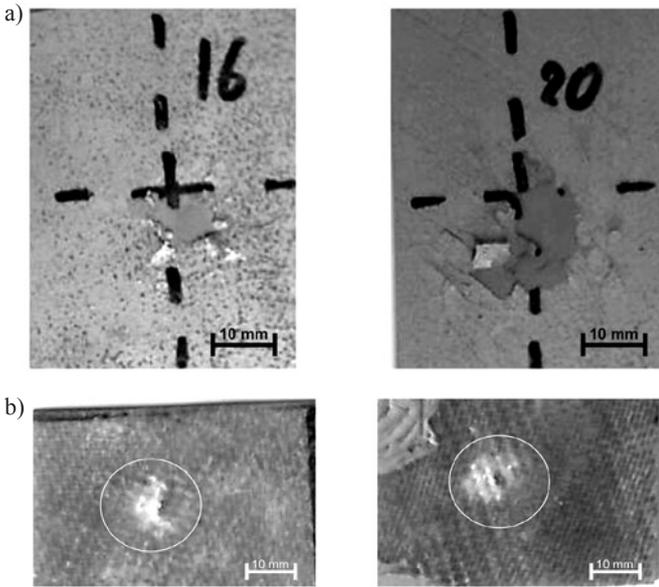
Fig. 9. Specimens after impact load of 10 J energy level: a) external side, b) inside

Cross-bending impact load of 10 J caused much higher damage. On the outer side of the specimen, covered in varnish coat, there was a noticeable varnish chip. The inside surface is bulged. Both the base and the reinforcement within the radius of 10 mm from the impact loading point are damaged. Within the damaged area one can observe broken fibres of the reinforcement. Also the base materials is fragmented in certain parts. (Fig. 9).

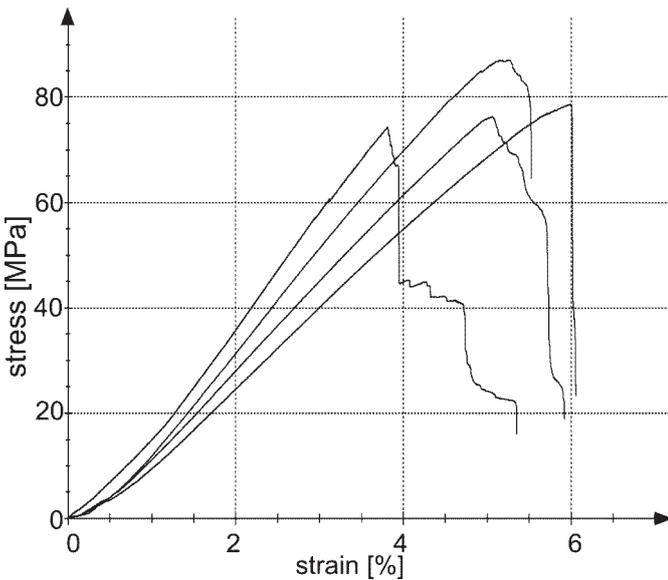
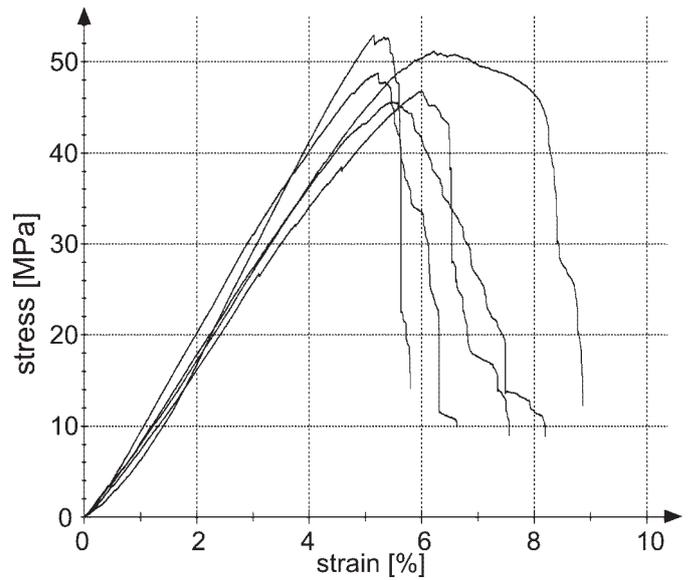
Fig. 10. Characteristics of specimens' bending strength: a) without impact load b) after 10 J energy level impact load

In a series of specimens which did not undergo impact load, the character of the damage is of two different kinds (Fig. 10a).

had the lowest bending strength. In this case, the bending strength fell by about 37% as compared to the undamaged material. Also the character of the bending curve became different (fig. 10b). On the basis of the macroscopic observation it was proved that due to a visible perforation of the laminate, the fibres which build the reinforcement material became damaged. The course of the damage, after exceeding the expansion limit R_g may prove that impact load, to a large extent, affects the material base, which leads to a gentle and gradual course of damage.

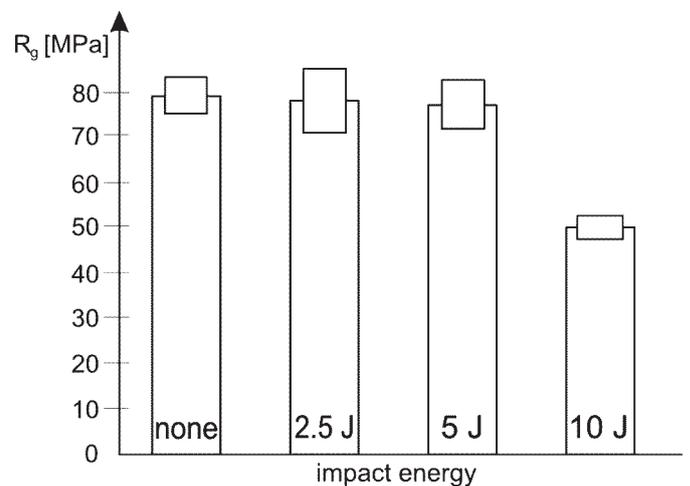
Fig. 11. Bending strength of the test specimens
