Jarosław GONERA
Jerzy NAPIÓRKOWSKI

MODEL FOR FORECASTING THE GEOMETRY OF THE FLOOR PANEL OF A PASSENGER CAR DURING ITS OPERATION

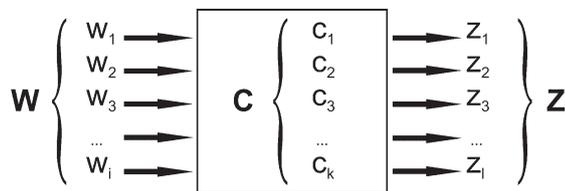
Fig. 1. A graphic illustration of the process of a car body wear during its use: C – a set of characteristics of an object, W – a set of excitations, Z – a set of responses of the object

During car use, wear processes take place which include changes in the geometry of the floor panel and upper parts of the body (Fig. 1). The geometry of a car body is characterised by a set of characteristics C . A body during car use is subjected to a variety of excitations W , which bring about changes of geometry, which in these cases are responses to the wear process Z .

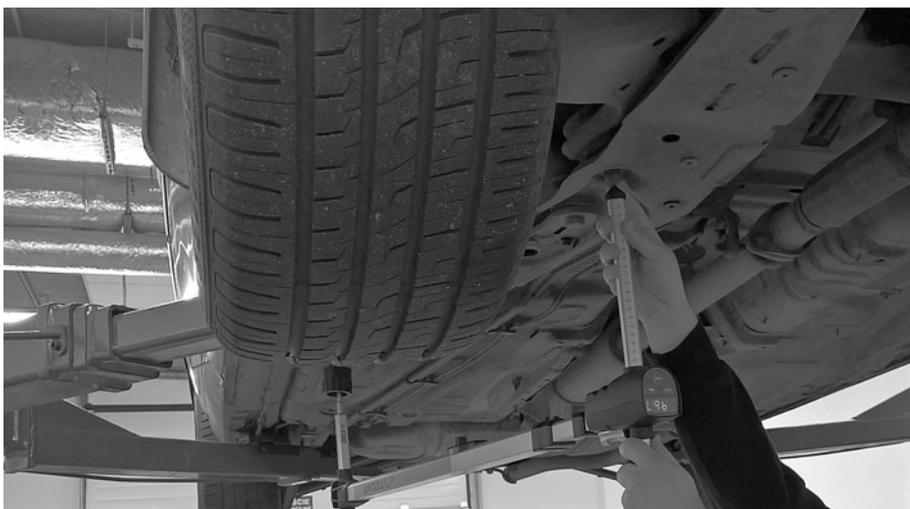
Fig. 2. Measurements of the floor panel geometry with a GYSMETER device manufactured by GYS

The floor panel geometry was measured with an accuracy of 1 mm with a Gysmeter device manufactured by Gys (Fig. 2). The measurement range of the Gysmeter device was between 400 and 2650 mm. The measurement device was equipped with a dedicated set of measurement tips, fitted to the base points under analysis. Owing to the set, measurements could be conducted without dismantling parts of the suspension and steering system. The actual position of the characteristic base points was measured and compared to the position required by the vehicle manufacturers. The measurements were made relative to the reference points, situated at the back part of the car, in the rear of the passenger compartment. No changes in geometry, including deformations, were identified at the reference points in the cars under study. The data on the position of the base points on the floor panel were taken from the database in the Allvis Light programme. This provides the required distance (in mm) between individual base points.

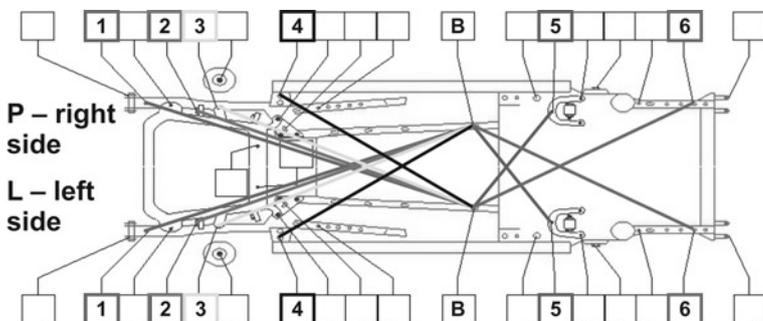
Fig. 3. Deployment of points at which measurements of the floor panel geometry was conducted, where: B – reference points, initial during the measurements; 1 – points situated at the beginning of the front longitudinals; 2 – front suspension fixing points; 3 – rear points fixing the front bench; 4 – points situated near the bulkhead; 5 – rear suspension fixing points; 6 – points situated at the end of the rear longitudinals

An analysis was conducted of the characteristics associated with (Fig. 3):

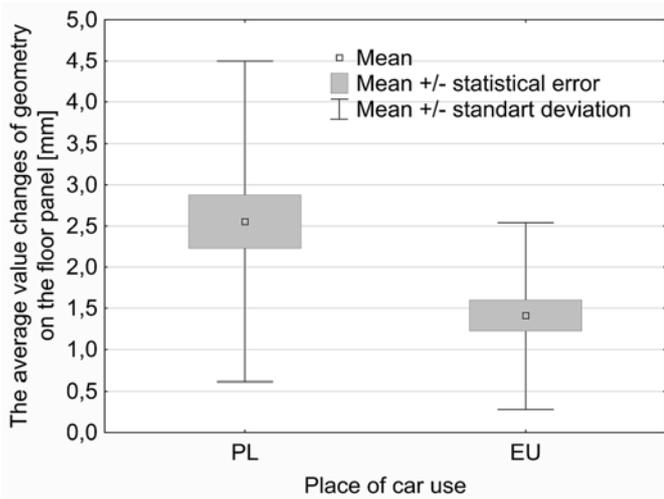
Fig. 4. A comparison between the base points displacement in cars depending on the country of use

The analysis of variance has shown that changes in the floor panel geometry in cars used in Poland and in Western Europe differed significantly (Fig. 4).

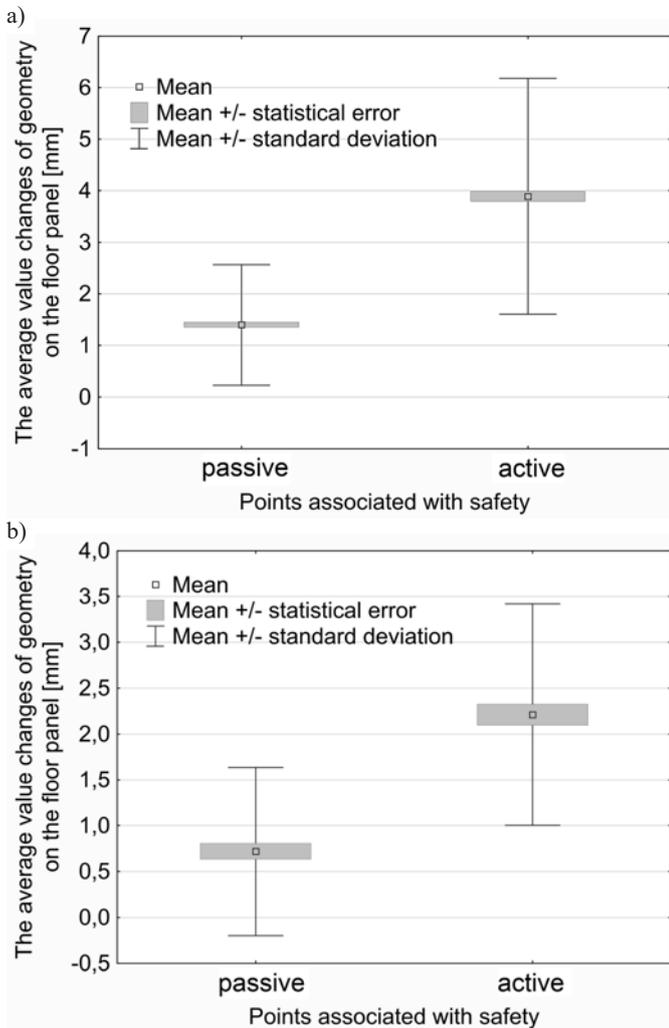
Fig. 5. A comparison between the base point displacements in cars used on roads: a. in Poland. b. in Western Europe. depending on the type of safety for which they are responsible

This study also employed an analysis of variance, whose aim was to determine the effect on the geometry changes in the type of safety for which the given base points are responsible (Fig. 5) and the side of the car where they are situated (Fig. 6).

Significant changes were found between the base points related to passive and active safety. Such differences were observed both in cars used in Poland and in those used in Western Europe. Greater geometry changes were observed at the base points related to active safety. Moreover, greater changes in the floor panel geometry - both in the cars used in Poland and in those used in Western Europe - were observed at the points situated on the right than on the left side of the car body.

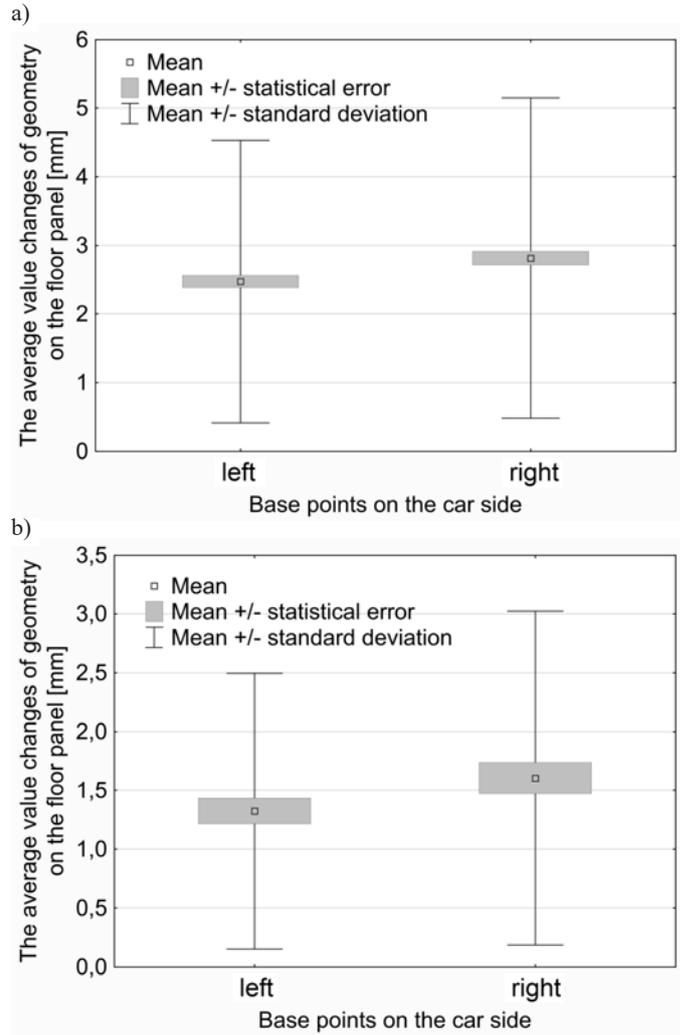
Fig. 6. A comparison between the base point displacements in cars used on roads: a. in Poland. b. in Western Europe. depending on the side of a car where the points were situated

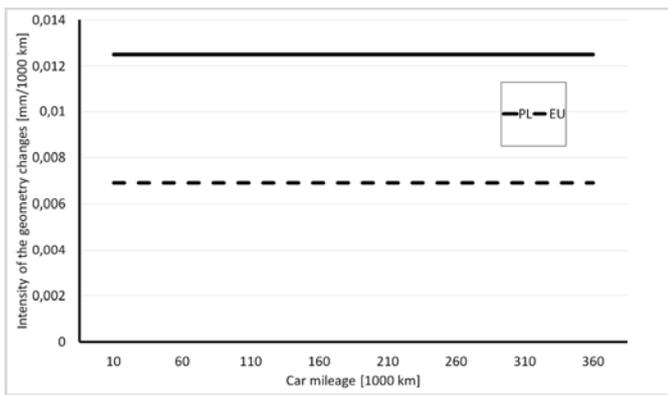
Fig. 7. Intensity of the floor panel geometry changes in cars used in Poland and in those used in Western Europe

The intensity of the floor panel geometry changes was constant, regardless of the car mileage (Fig. 7). However, an increase in the total geometry changes was observed with increasing mileage. The intensity of the geometry changes depended on the country in which a car was used, the type of safety for which the base points were responsible and the side on which they were situated. Tables 2 and 3 show the intensity of the floor panel geometry changes observed in this study.

Greater changes of the floor panel geometry changes in regard to the mileage were observed in the cars used in Poland. They were twice greater in virtually all cases. Moreover, several times greater changes were observed at points responsible for active than those responsible for passive safety of a car. The differences between the geometry changes on the right and left side of a car were not significant.
